Home Report

Pierowall Cottage
Pierowall
Westray
Orkney
KW17 2BZ

Property address: Pierowall Cottage

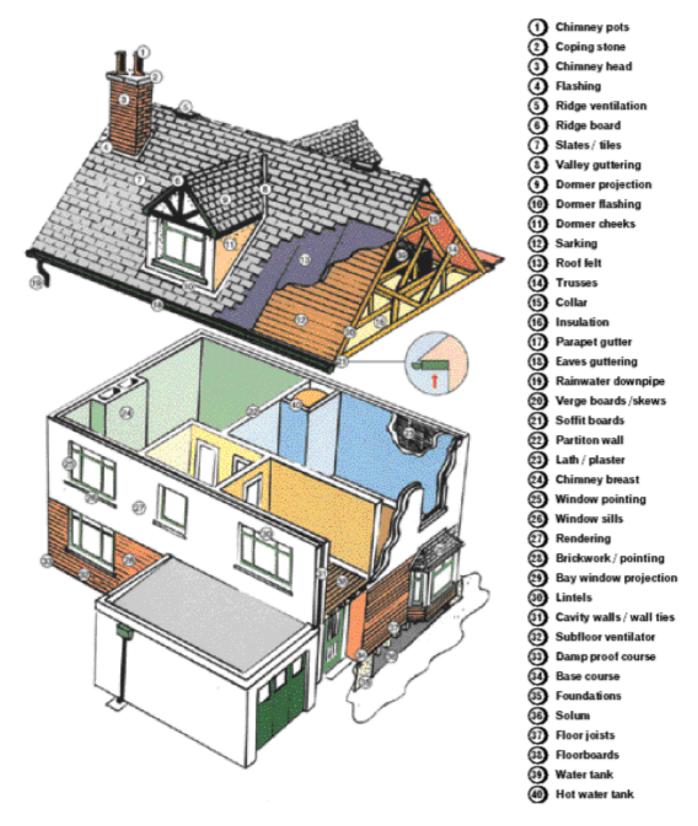
Sectional diagram showing elements of a typical house

Reference may be made in this report to some or all of the above component parts of the property. This diagram may assist you in locating and understanding these terms.
