Single Survey Report

**Hoy Lodge
Hoy
KW16 3NJ**

N J Coward, MRICS
The Office
Burgar House
Evie
KW17 2NJ

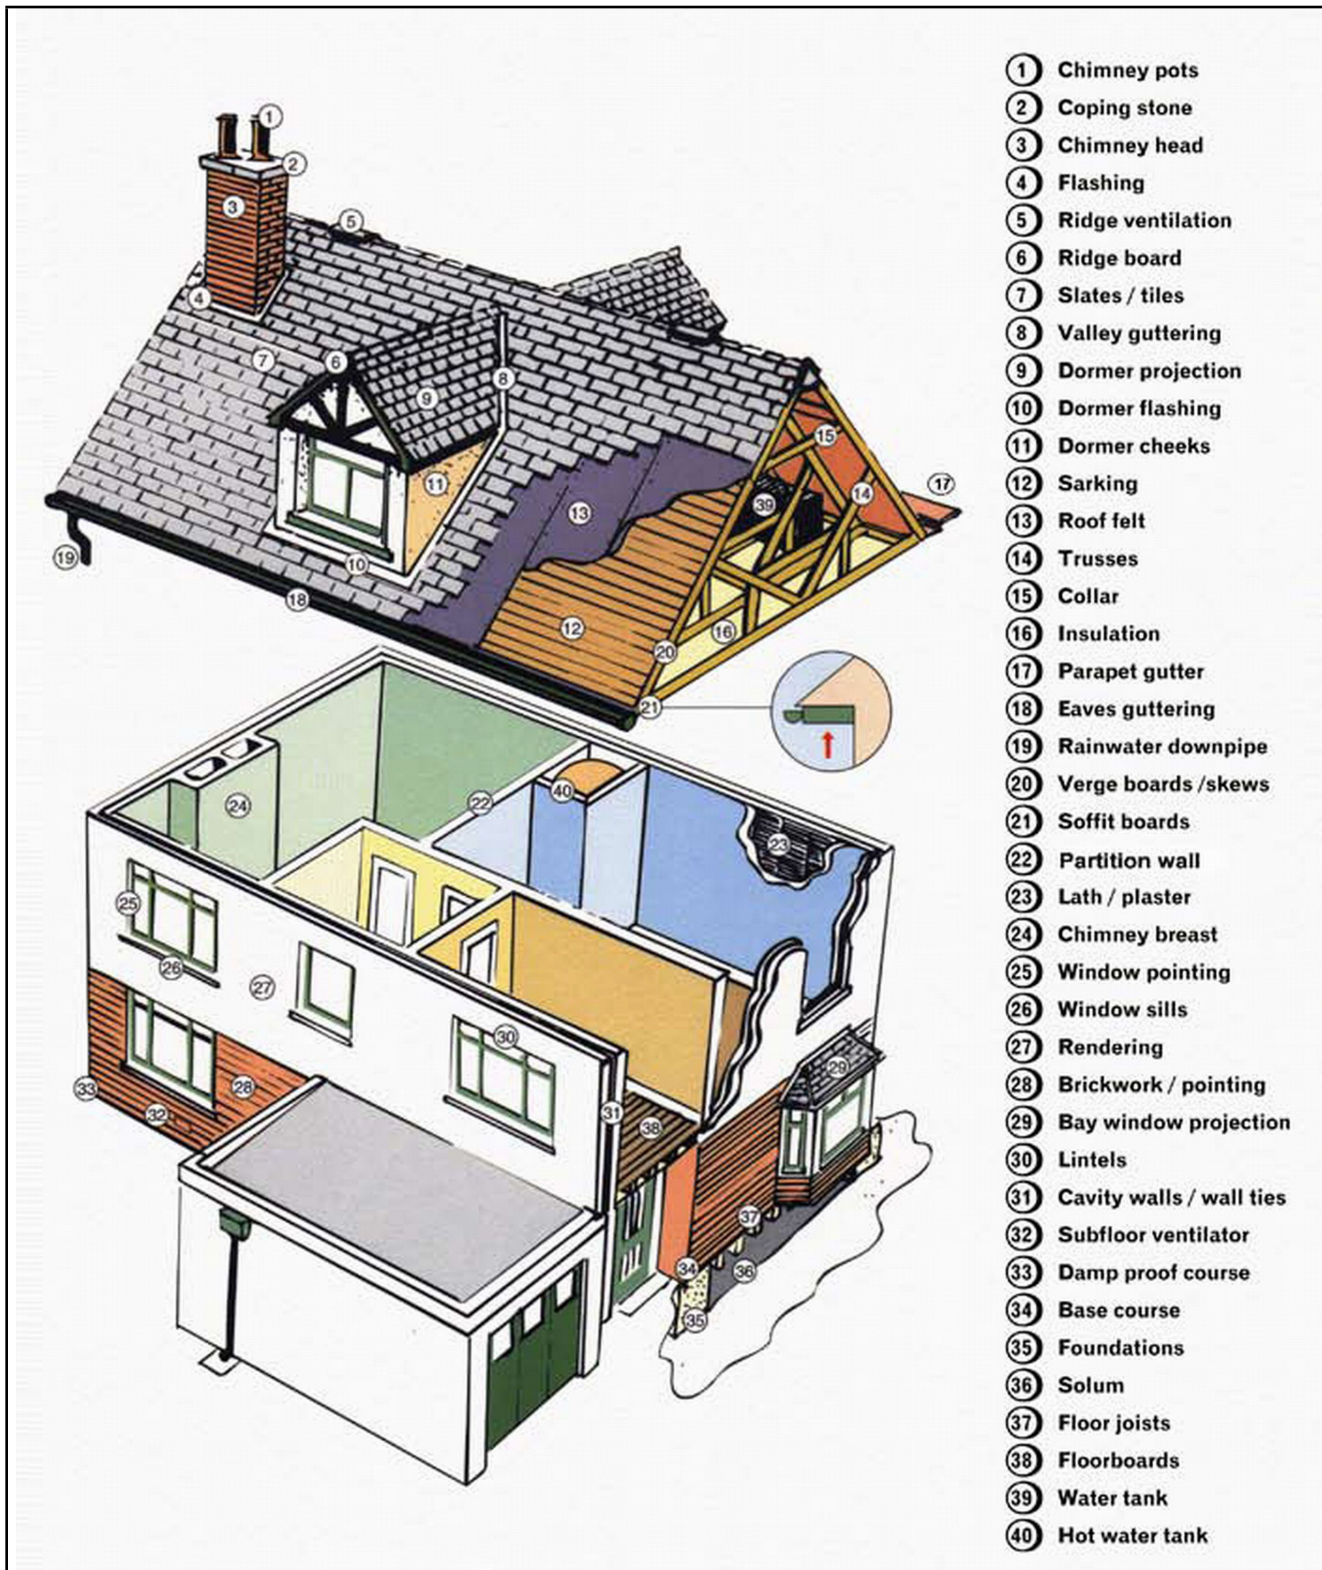
Sectional diagram showing elements of a typical house

Reference may be made in this report to some or all of the above component parts of the property. This diagram may assist you in locating and understanding these terms.
